## *Mir Solar Array Return Experiment*

*James Visentine, Boeing; William Kinard, Langley Research Center; David Brinker, David Scheiman, and Bruce Banks, Lewis Research Center; James Zwiener, Marshall Space Flight Center; Keith Albyn, Johnson Space Center; and Thomas See, Lockheed-Martin*

*1998 Space Environments and Effects Program*

## Mir SARE (Solar Array Return Experiment)

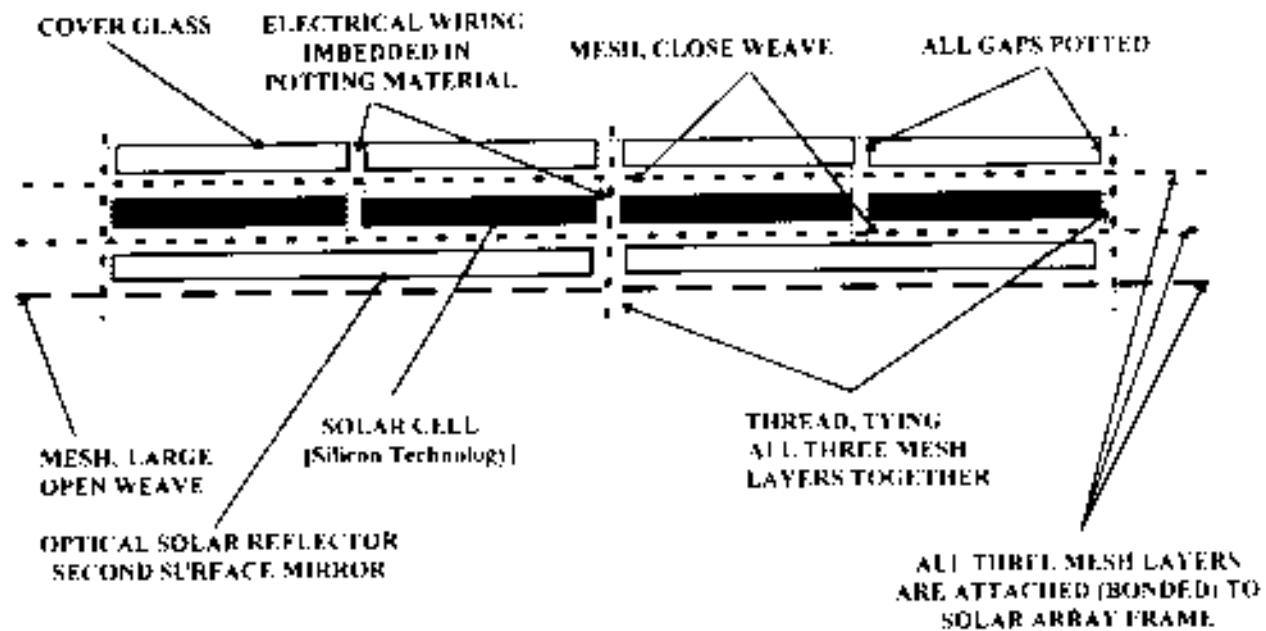
- Each solar cell has cover glass with anti-reflection coating to improve light transmission properties. All spacings and joints between cells filled & sealed with organic potting material.

- Cover glass is bonded to layer of fabric mesh which is tightly woven and impregnated with organic adhesive
- Solar cells are each bonded to this fabric layer and to a second layer of fabric mesh which is attached to backside of each cell within panel sections

- Bonded to backside of second layer of fabric is an Optical Solar Reflector
- OSR's used to reject heat from two adjacent solar cells attached to its surface and to minimize heat input into PV array when exposed to reflected, or direct sunlight

- Polymer backside netting, large open-weave organic fabric, was physically attached between cells with organic threads which tied all three fabric layers together. Netting fabric supported cells during manufacturing process and provided mechanical strength during launch, ascent, and array deployment

Figure 4. Cross section of the returned Russian solar array.

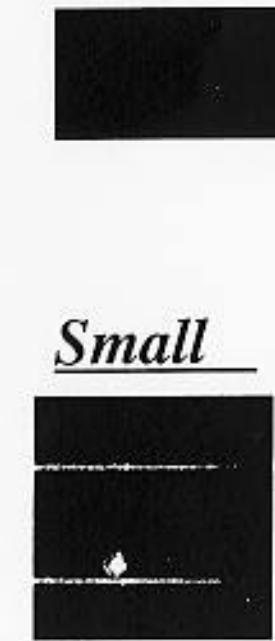
Small

> 0.3 mm Diam.

*Penetration  
limited to  
cover glass.*

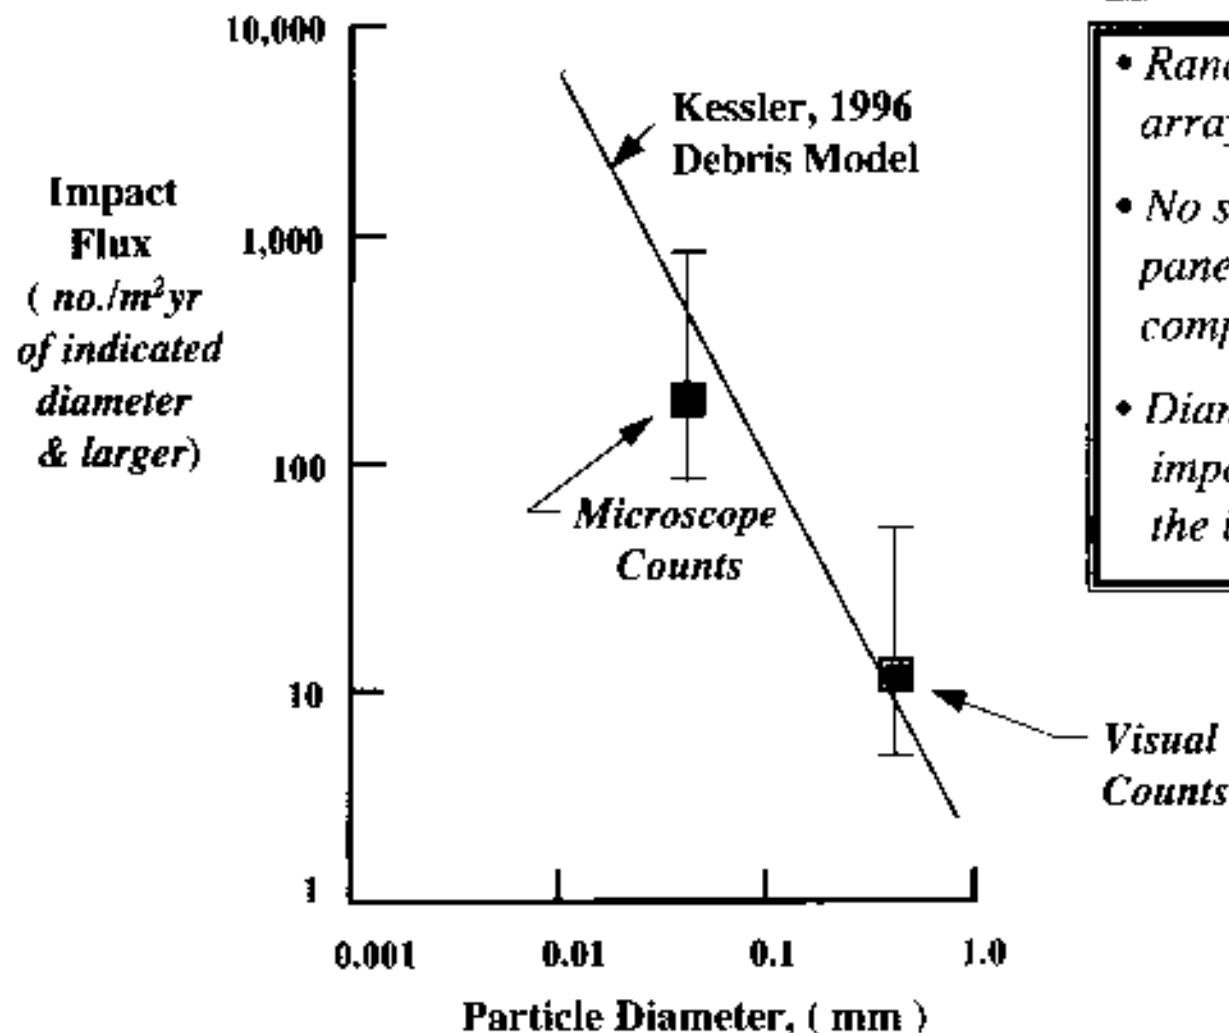
# *Debris Impact Fluxes Indicated by Crater Counts*

## Assumptions -

- Random orientation of array panel.
- No shielding of array panel by other Mir components.
- Diameter of damage at impact sites is 10 times the impactor diameters.

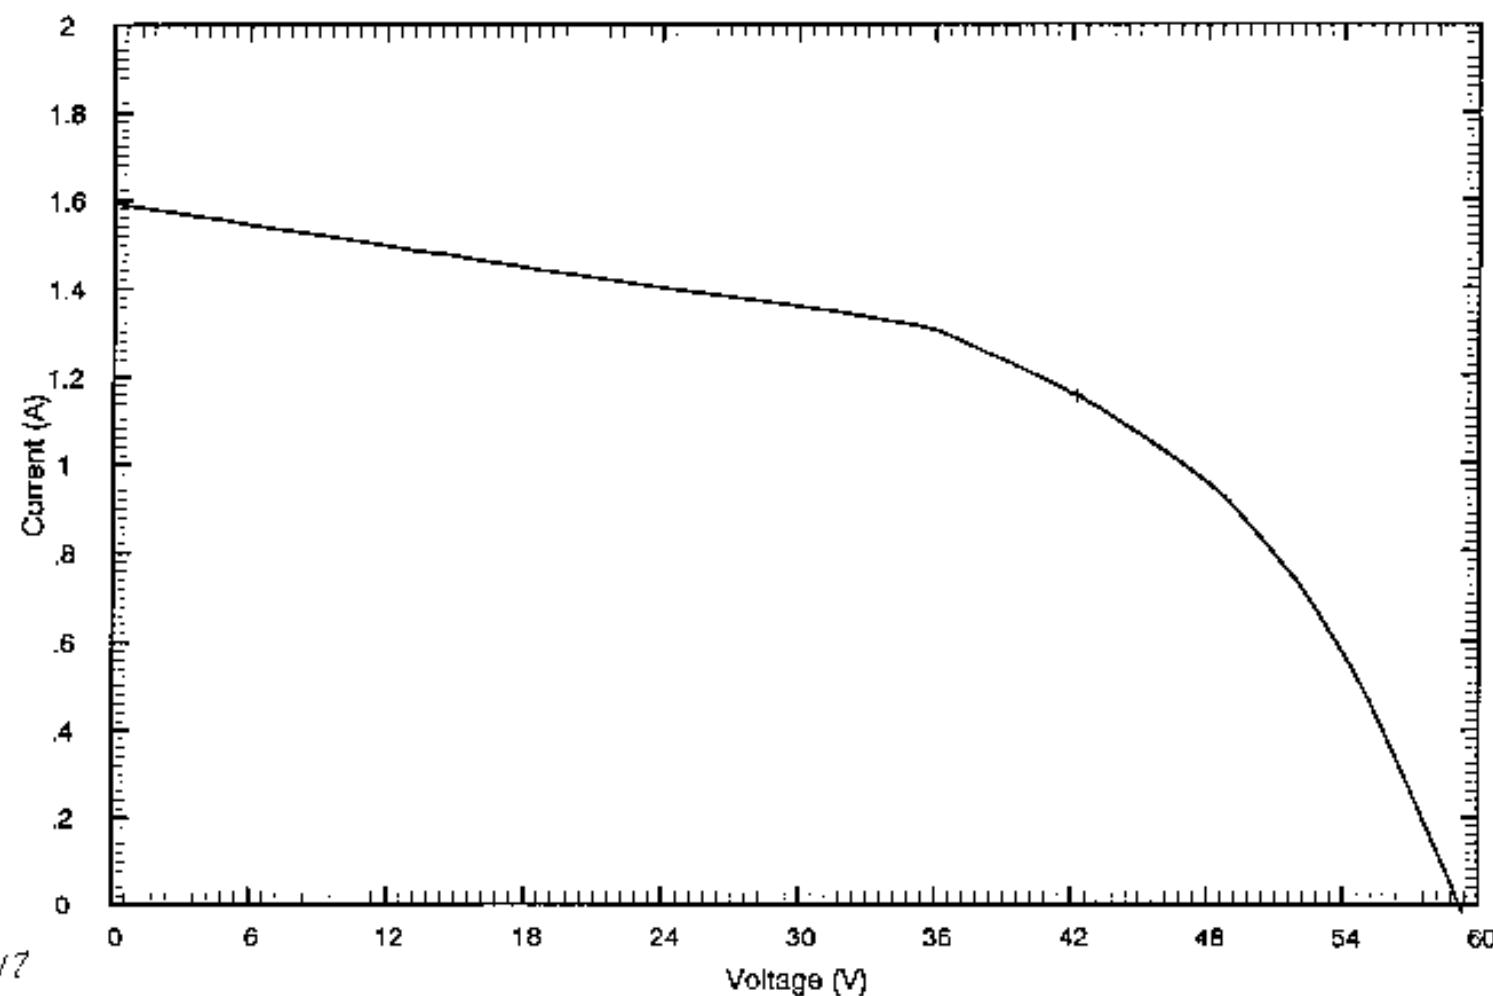
- SARE PV panel section was inspected, tested, and evaluated by U.S. specialists at NASA Lewis Research Center
- Evaluation tests consisted of illuminating entire panel section with one sun solar radiation intensity and measuring power output performance
- Test Measurement Results:
  - Panel Operating Temperature: 25 °C
  - Panel Area: 7,409 cm<sup>2</sup>
  - Short Circuit Current: 1,595 mA
  - Open Circuit Voltage: 59 Volts
  - Maximum Power Output: 48.7 W (1,153 mA @ 42.2 V)
  - Fill Factor: 0.516 (Original F/F was probably 0.70 - 0.75)
  - Power Efficiency: 4.81% (Original P/E was probably 10-12%)
- Component tests are presently underway to measure the performance and efficiency of ten solar cells individually removed from SARE panel section

Cell ID : Panel 8  
Date : 04-23-1998  
Area : 7409 cm<sup>2</sup>  
Temperature : 25 °C  
Data is not temp corrected  
10 years on MIR  
File : LAP1139.I\_V

I<sub>sc</sub> = 1595.2 mA  
V<sub>oc</sub> = 59.158 V  
I<sub>max</sub> = 1153 mA  
V<sub>max</sub> = 42.212 V  
P<sub>max</sub> = 48.672 W  
F.F. = .516  
Eff. = 4.81 %
